# Scanning Electron Microscopy in Failure Analysis and Accident Investigations

**M.A. Venkataswamy**

National Aerospace Laboratories, Council of Scientific and Industrial Research (CSIR), Bangalore-560017, INDIA  
E-mail: swamy@nal.res.in

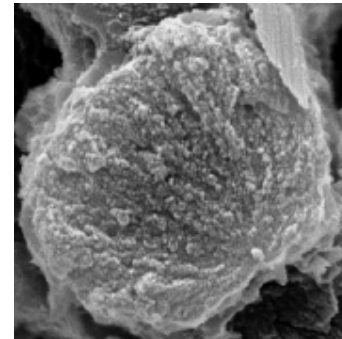
Macroscopically, existence of discrete fibers (or bundles of fibers) pulled from the surrounding matrix is indicative of failure in tension. One of the microscopic features indicative of tensile type failure is the characteristic known as fibre radials. The failure origins can be traced using the fibre radials.

**Fig. 6:** Fiber Radials Observed in Tension Failure of Fibers

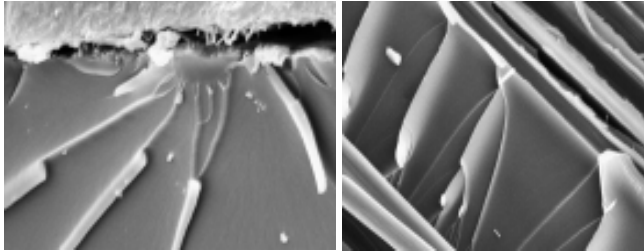
Two features characteristic of matrix tensile fracture: river markings (Fig. 7a) and hackles (Fig. 7b). Hackles are numerous platelets of fractured epoxy distributed in rows between fibers. Hackles have been observed under a variety of failure conditions including interlaminar and intralaminar delaminations, as well as pulled-out fibers under tension.

**Fig. 7:** (a) River Pattern;  
(b) Hackles Observed in Tension Failure of Matrix

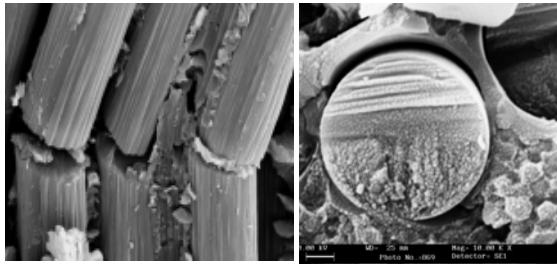
The macroscopic appearance of the fracture surface will be relatively smooth and will be oriented at an angle of 30–45° to loading direction. Fiber kinking (Fig. 8a) is a characteristic of compression failure. At high magnifications, the fracture surface of the individual fibers showed two distinct areas of compressive and tensile areas separated by neutral axis known as chop marks (Fig. 8b).

**Fig. 8:** (a) Fiber Kinking, (b) Tension and Compression Regions Separated by Neutral Axis (N.A)

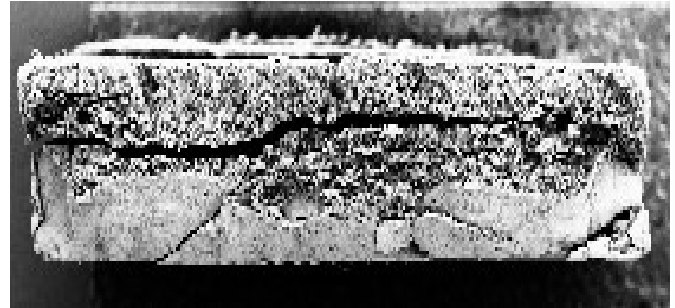
Flexural failure in unidirectional laminates shows areas of tensile fracture and compressive fracture, the boundary between them being parallel and often close to the neutral axis of the laminate on the individual fibre ends (Fig. 9). Flexure produces an overall fracture topography somewhat similar to that noted for individual compressive fibre fractures.

**Fig. 9:** Fracture Surface Showing Rough Surface on Tensile Side and Smooth Surface on Bottom Compression Side

The tensile and compressive loads applied during flexure generate relatively large-scale areas of compressive and tensile fiber fracture, separated by a distinct neutral axis line. The position of the neutral axis may be of value in reconstructing the loading conditions of flexure at the time of failure.
